High Temperature Erosion Testing in a Gasifier Environment

J. Tylczak¹, J. Rawers¹, and T. Adler¹

¹Albany Research Center, USA

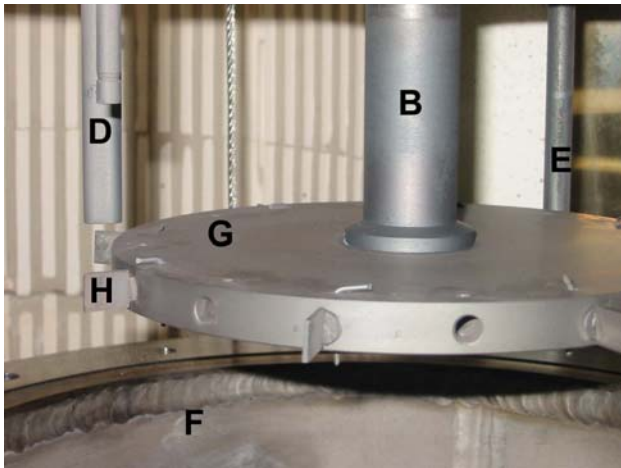
Figure 2. Parts associated with HAET apparatus. Note in this case the test specimens are mounted in alternating locations in mounting disk for testing at 20m/sec erosion velocity.

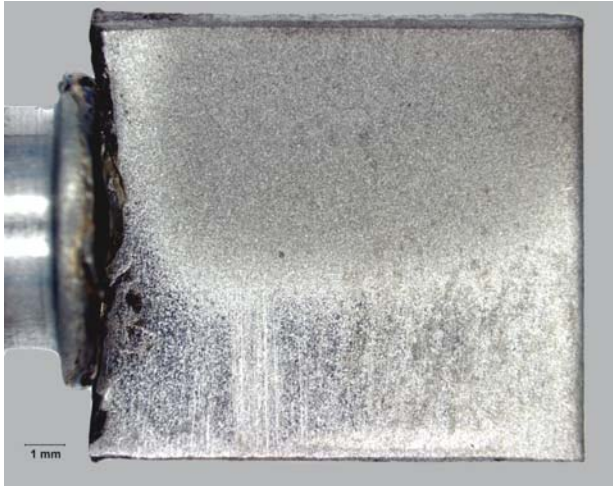
Figure 3. . A Waspaloy sample after room temperature testing that shows the typical roughing of the surface during testing.

All of the materials tested at room temperature with an erosion velocity of 20 m/sec performed well. The visual inspection of each sample noted no more than a roughing of the upper 3/5th of the surface that was exposed to the erosion. Figure 3 shows a typical sample after testing at room temperature. The lack of corrosion and much erosion was further verified when the samples were weighed and very low levels of weight loss were measured.

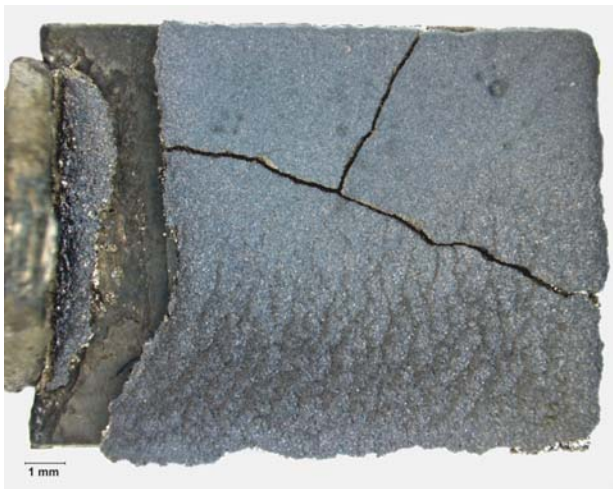
Figure 4. The 9 Cr 1 Mo sample after testing at 700°C. The thick fragile upper scale is partially removed exposing the next layer of scale.

While 9 Cr 1 Mo steel performed essentially the same as other materials at room temperature, this was visually the worst performing material tested at 700°C. Both the corrosion and the erosion/corrosion specimens showed virtually no differences. In both cases there was a thick outer scale that sloughed off easily during handling. Figure 4 shows a 9 Cr 1 Mo steel sample after testing. The upper thick layer of scale has broken free showing a lower more adherent layer below. On the eroded/corroded sample there was some discoloration of the outer layer where the erosion took place, along with some smoothing of this outer rough scale. Below the outer scale was a thick dark inner scale. This scale was very smooth, still showing polishing features of its preparation. Finally below this layer was the metal with a thin layer of corrosion on the surface. The metal was mostly consumed during the test.

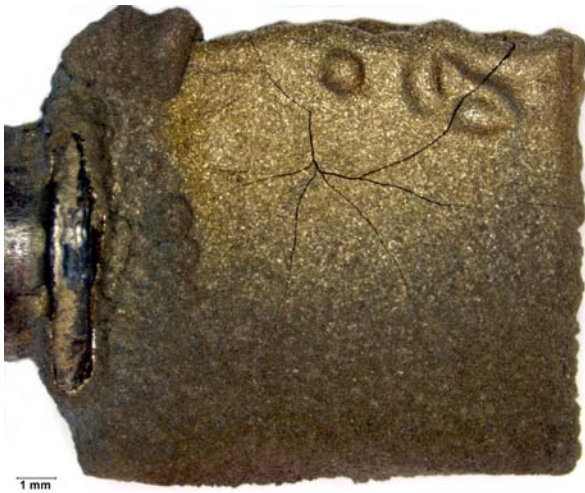
Figure 5. Waspaloy sample eroded at 700°C in a gasifier environment. Specimen shows cracking emanating from the erosion/corrosion zone.

The Waspaloy after the 700°C test showed a corroded surface with a fairly thick rough scale that had a fine surface structure. The eroded/corroded surface showed a similar scale away from the erosion zone. At the erosion zone, figure 5, the surface appeared smoother due to the erosion impact. It was shinier and gold in color. Cracks were also seen radiating from the erosion zone, caused by the stresses as this compacted scale layer cooled off.

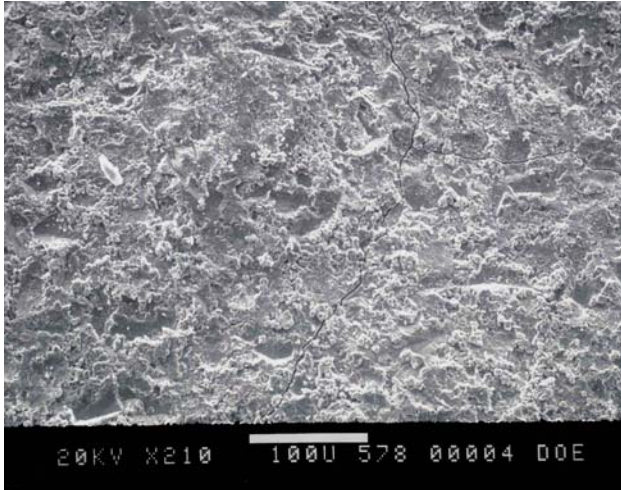
Figure 7. SEM image of HR-160 showing compacted surface scale from erosion/corrosion process.

The HR-160 sample, fig 7, showed various corroded/scale layers. Using EDS analysis on the different scale layers it was found that in the eroded/corroded region the thick scale layers were largely a (Fe, Ni)S compound. As the layers got thicker the ratio of Ni increased. Only in areas of thin scale was much Cr found. The metal in these thin scale areas was predominately Cr, with half as much Fe, a quarter as much Ni, and lower amounts of Co. The metal ratios continued to show a (Cr, Fe, Ni, Co)S compound was being formed. Along with the metals and S forming the surface scale, silica was mixed with the scale. Moving away from the eroded/corroded region the scale layer thinned out and the silica content decreased.

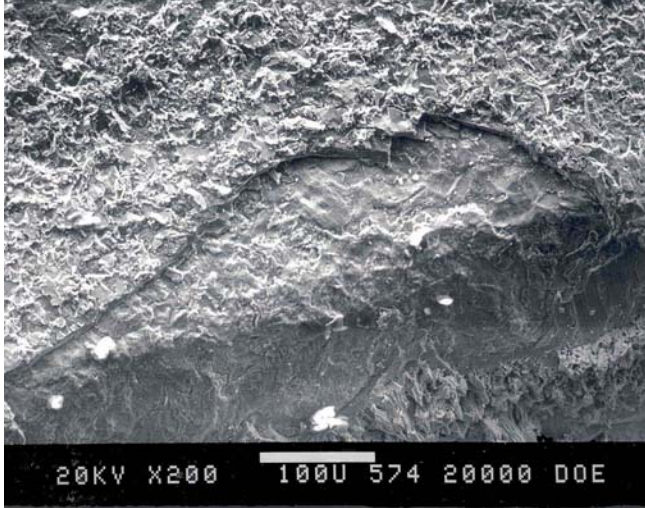
Figure 8. Image of edge of the eroded/corroded zone from the Waspaloy specimen. Picture shows a small area where the outer scale has been removed showing the two inner scale layers.

of varying composition. In this region there were areas that showed Mo, up to 14 pct, along with the Ni, Mo, Fe, and Cr. Below this layer was at least one further that showed fair amounts of Ti (up to 9 pct) and Cr (up to 40 pct) with some Ni and Fe. Fig 8 shows an area in the erosion/corrosion zone where the outer scale has been removed. The second layer of scale shows damage from the impact of the erodent. The impact-scale can be compared to the non-impact scale by looking down the corner of the specimen.
